WYMAN POND DAM

MA 00641

PHASE I INSPECTION REPORT
NATIONAL DAM INSPECTION PROGRAM

AUGUST 1978

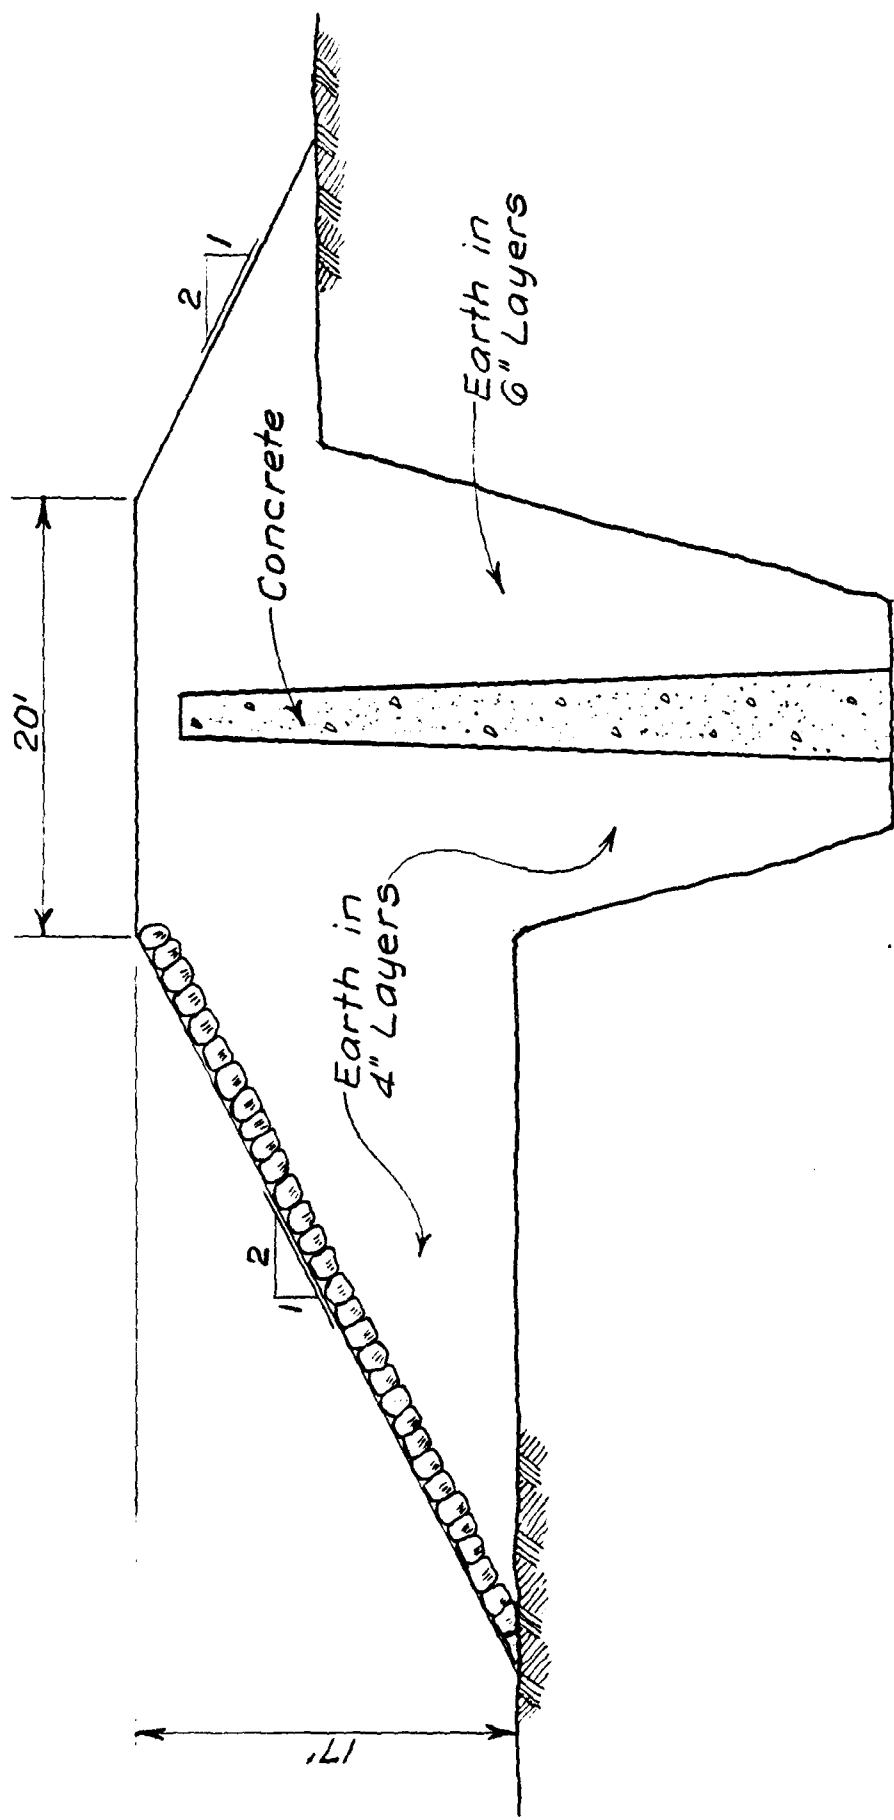
SECTION THRU EMBANKMENT

The only data known to exist is a drawing furnished by the City of Fitchburg, showing a cross-section of the dam and its general dimensions.
